MEMORANDUM

SUBJECT: Site Assessment: Certain-Teed-Maline Creek Site,
Bellefontaine Neighbors, St. Louis County, Missouri
TDD#: T07-9209-003
PAN#: EM00307SBA
EPA/OSC: Don Hamera

Photographic Record

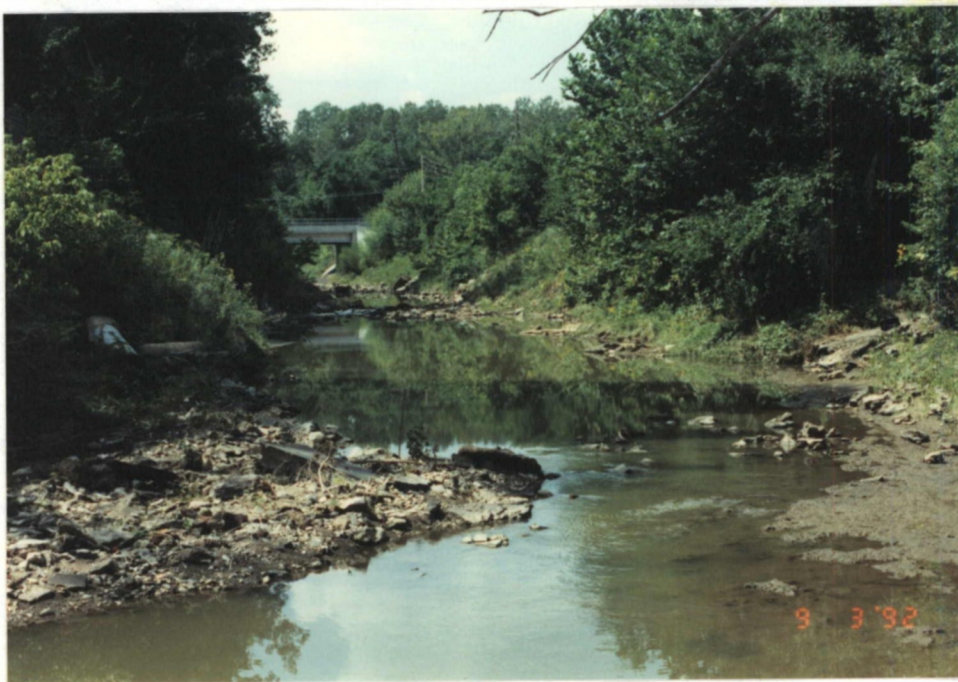
Photographer: Joe Parish
Date/Time : 9/3/92/1344
Lens: Type: 50mm/normal
Serial No.: 1063023
Frame No. : 10
Direction : W
Comments :

Looking upstream toward bridge
over Maline Creek at
Bellefontaine Rd.

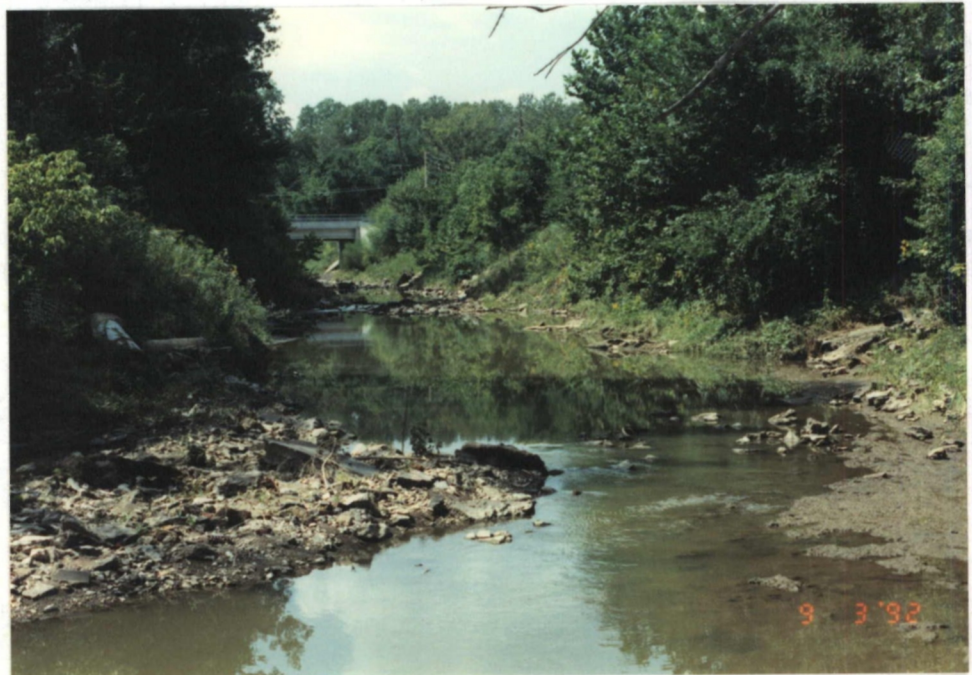
Looking upstream toward bridge
over Maline Creek at
Bellefontaine Rd.
